NRAY Neutron Radiography Sample Image - Corrosion

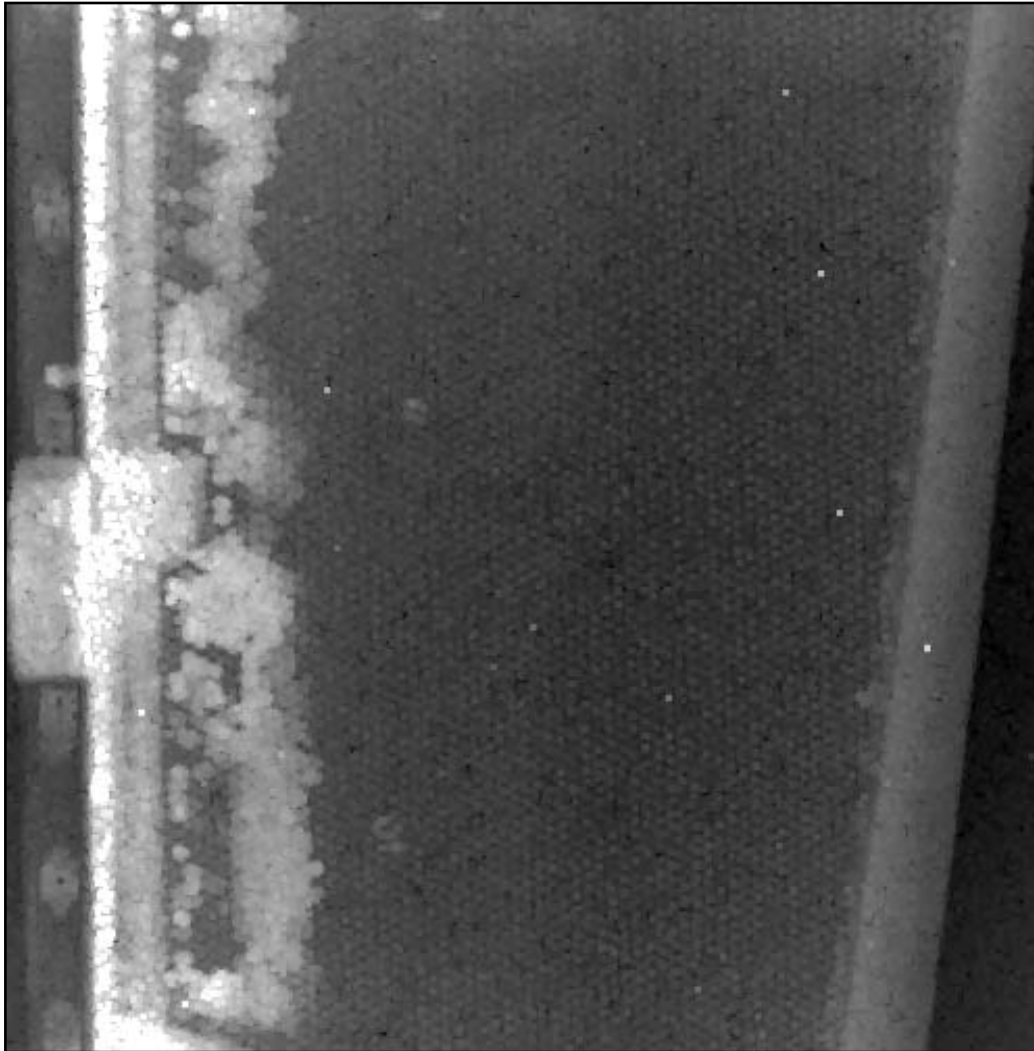
Shown above is a neutron radiograph of the honeycomb structure of an aircraft flight control surface. Along the left vertical edge of the image is a white band; water and corrosion in the Aluminum honeycomb structure. Neutron radiography can be used to effectively image water and corrosion within Aluminum products.
