NRAY Neutron Radiography Sample Image - Rubber and Hydrogenous Materials

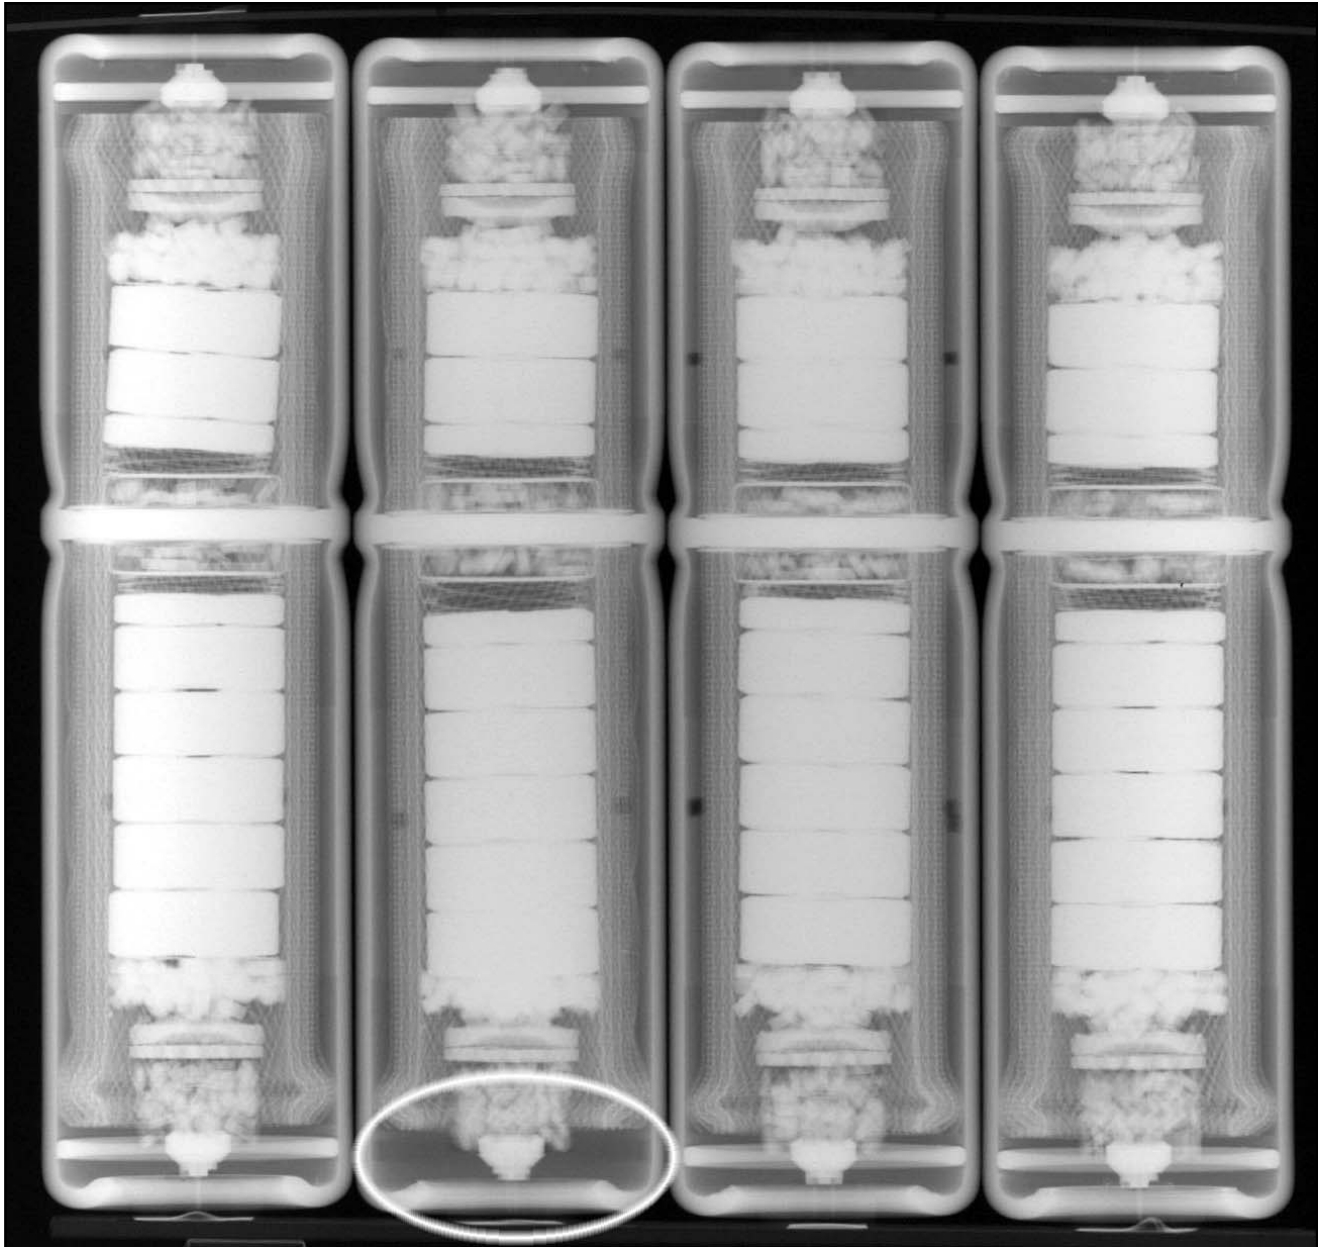
The image above is a neutron radiograph of four air bag initiators. The second part from the left is missing an o-ring at the bottom and is therefore dysfunctional. Due to the ability of neutron radiography to image rubber and other hydrogenous materials so well, it is an effective complex component reliability testing technique
